Burner Rig Evaluation of Thermal Barrier Coating Systems for Nickel-Base Alloys

Michael A. Gedwill National Aeronautics and Space Administration Lewis Research Center

February 1981

U.S. DEPARTMENT OF ENERGY Fossil Energy Office of Coal Utilization

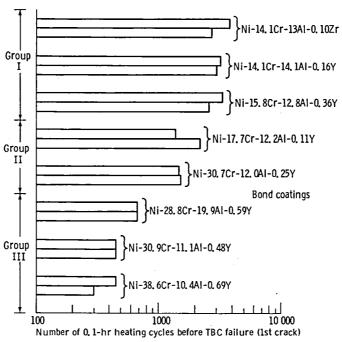
The TBC failures observed visually on the figure 2 specimens occurred by cracking followed by spalling of the ceramic coating (table II). Typical examples illustrating the extent of cracking and spalling of these TBC systems are presented in figure 3. All the failures of the ceramic coating apparently started on the back surface of the specimens (fig. 3(a)), which was at a higher temperature (~1150°C) in the burner flame than the front surface. (Maximum temperatures measured on metallic specimens in a burner flame were reported to be the highest on the back surface (ref. 16).) In some cases, the cracking/spalling progressed around the specimen to the front surface (fig. 3(b)), on further cycling if cracking was severe. The least effective, Group III bond coatings were also observed to have cracked and spalled at the end of testing (fig. 3(c)), except in one instance (table II). As is also evident in figures 3(a) and 3(b), the ceramic coating is discolored, primarily on the front surface. In general, all the specimens were discolored after about 1600 test cycles, i.e., after ~ 160 hours in the burner flame. The discoloration varied from reddish-brown to almost black. Examinations in a scanning electron microscope (SEM) using an energy dispersive X-ray spectrometer indicated that the discoloration was due to iron-containing deposits (probably iron oxide(s)). It is believed that the deposits were present in the combustion air because oily reddish-brown deposits have been observed in the combustion air flowmeters. It is believed that the deposits had no effect on the performance of these TBC specimens. The work of Zaplatynsky (ref. 17) showed that Fe_2O_3 does not react with $Zr0_2-8Y_20_3$ at 1200° C for times up to 400 hours. The specimens tested in the present study using the 0.1-hour heat cycles were at < 1150 $^{\circ}$ C for

Figure 2. - Performance of TBC systems on solid Rene´ 41 pins in Mach 0.3 burner rig oxidation.

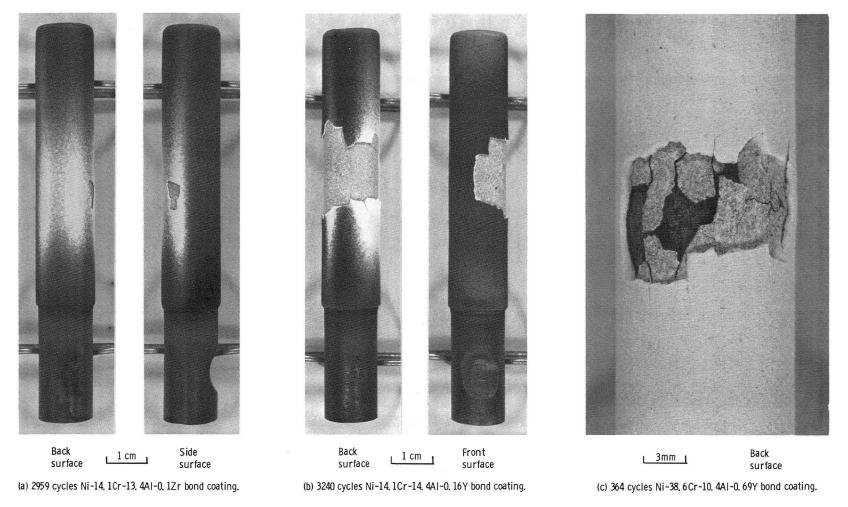
Figure 3. - Photographs of TBC René 41 solid pins after cyclic oxidation exposure in a Mach 0.3 burner rig. Maximum temperatures at 3.2 cm from top: 1050° C at center line of pin, $\sim 1150^{\circ}$ C on back surface. Heating cycles: 0.1 hour.

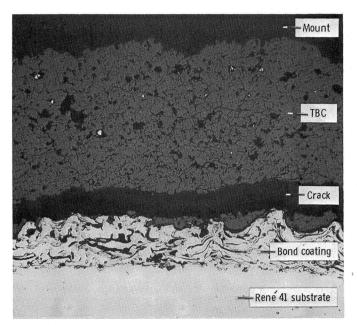
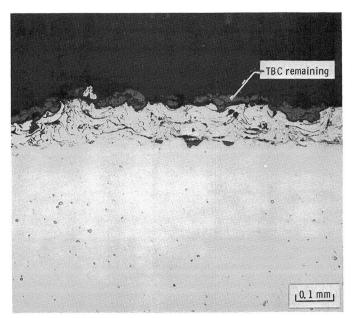
(a) $\rm ZrO_2$ -12 $\rm Y_2O_3/Ni$ -14. 1Cr-13. 4AI-0. 10Zr TBC system after 2748 cycles.

Metallographic cross sections in the zone of maximum failure of two specimens after test are shown in figure 4. Figure 4(a) is typical of the tested specimens with the Group I bond coatings, while figure 4(b) is typical of those tested with the poorer Group III coatings. The ceramic coating on the front surfaces of the two specimens of figure 4 is in place, but cracked. Similar cracking within the ceramic near the ceramic/bond coating interface has been reported (refs. 7, 10, 14, and 18). On the back surfaces of these two specimens, the ceramic coating has spalled off, except for some small remnants attached to the bond coatings. With the best bond coatings (Group I), the ceramic coating failed well before the bond coatings were appreciably oxidized. The bond coating in figure 4(a), however, is less oxidized on the front and back surfaces after a longer exposure in the burner rig than the poorer bond coating shown in figure 4(b). Also, there is less oxide penetration into substrate in figure 4(a). The severe oxidation that occurred in the bond coating and along the substrate/bond coating interface on the back surface of the figure 4(b) specimen led to cracking and spalling of the bond coating similar to that shown previously (fig. 3(c)). The specimens with the Group II bond coatings (not shown in fig. 4) were oxidized to an intermediate degree. These observations suggest that volume expansion along the ceramic/metal interface as a result of bond coating oxidation plays a key role in unzipping the ceramic.

Figure 4. - Photomicrographs of TBC René 41 pins after cyclic oxidation testing in a Mach 0, 3 burner rig at 1050^{0} C. Heating cycles: 0, 1 hour. Bond coatings applied at 20 kW using argon -3, 5 v to hydrogen. TBC: 0, 038 cm.

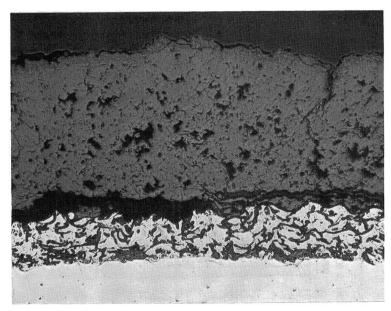
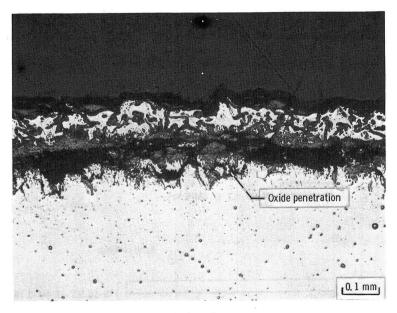
$\label{eq:Back surface} Back surface$ (b) ZrO2-12Y2O3/Ni-28, 8Cr-19, 9AI-0, 59Y TBC system after 738 cycles.

Figure 4. - Concluded.

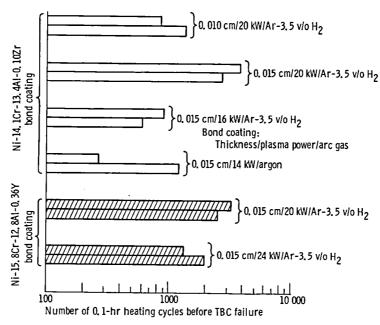
Figure 5 shows the effects of bond coating thickness and plasma spraying conditions on the performance of two TBC systems in the Mach 0.3 burner rig test using the 0.1-hour heating cycles. Increasing the thickness from 0.010 to 0.015 cm had a beneficial effect on performance, i.e., at least a 100 percent increase in the number of cycles to failure. In cyclic furnace testing of bond coatings deposited on nickel and cobalt-base alloys, it was shown that the oxidation resistance decreased drastically when the coating thickness was reduced from 0.015 to 0.010 cm (ref. 14). Although not investigated in the present study, bond coatings thicker than 0.015 cm might give further improvement in the burner rig lives of TBC systems. In a study involving cyclic furnace testing of various ZrO2-Y2O3/NiCrAlY TBC systems, Stecura (ref. 8) concluded that increasing the average bond coating thickness to 0.020 cm was desirable. However, turbine choking may limit the benefits of thicker coating systems.

As shown in figure 5, the performance of TBC systems in the burner rig test was affected by the plasma arc power used in applying the bond coatings. Either decreasing or increasing the power from 20 kW resulted in poorer performance, i.e., about a 20- to 90-percent loss in the number of cycles to failure. These observations are in complete agreement with the performance of bond coatings deposited on nickel and cobalt-base alloys noted in the previous study using furnace testing (ref. 14). In that study, it was also found that a little hydrogen in the arc gas improved the oxidation resistance of the coatings. The results obtained in the burner rig and

Figure 5. - Effect of bond coating thickness and plasma spraying conditions on performance of $\rm ZrO_2$ - $\rm 12Y_2O_3$ TBC systems on solid Rene´41 pins in Mach 0.3 burner rig oxidation. TBC thickness: 0.038 cm. Maximum exposure temperature at center of pins: $\rm 1050^{9}$ C.

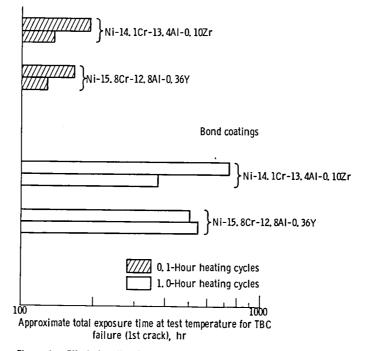
The effect of thermal cycling frequency on TBC performance is shown in figure 6 for two systems in the Mach 0.3 burner rig. Using the short, 0.1hour heating cycles, the lives of the TBCs in the 1050°C rig test were less than 200 hours. The lives, however, were increased by a factor of about 2 to 5 with the longer, 1.0-hour heating cycles. These results, therefore, show that less frequent thermal cycling greatly increases TBC life in terms of time at temperature. However, the fact that the improvement is not 19-fold (ratio of time at test temperature in the long cycles to that in the short cycles, i.e., 57/3) indicates that life is governed by a combination of a thermal cycling component as well as a time at temperature component. The thermal exposure component may be associated moreso with poor oxidation resistant bond coatings or with the ceramic coating when oxidation resistant bond coatings are used. The results are in agreement with the findings reported by McDonald and Hendricks (ref. 13). Their experiments showed that with the poor Ni-16Cr-6Al-0.3Y bond coating, repeatedly subjecting a ceramic coating to high initial heating rates such as those in a Mach 0.3 burner rig was the destructive influence on the coating rather than sustained operation at elevated temperature, whereas a time at temperature component was evident with a better bond coating. Their stress calculations showed that the large thermal stresses, which result from the high initial rates of heat transfer, tend to detach the ceramic coating. These calculated stresses were found to be within the range of measured values of the adhesive/cohesive strength of the ceramic coating.

Figure 6. - Effect of cycling frequency on performance of TBC systems on solid Rene 41 pins in Mach 0.3 burner rig oxidation. Bond coatings: 0.015-cm thick applied at 20 kW using argon - 3.5 v/o hydrogen plasma arc gas. TBC: 0.038-cm thick ZrO₂-12Y₂O₃. Maximum temperature at center of substrate: 1050^o C.

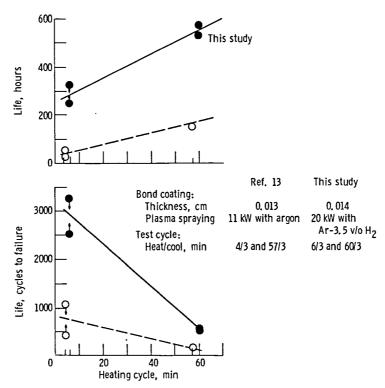
Figure 7 shows a comparison of the data obtained in the present study with data for the better bond coating reported in reference 13. Here the data are presented in the same manner as in reference 13 and are for the same materials tested under similar conditions. Differences in the two tests are documented in figure 7. As stated above, the trends in the two studies were in agreement. However, the specimens tested in the present study had significantly longer lives (in terms of either time at temperature or number of cycles to failure) in both the short (0.1-hr heating cycles) and long (1.0-hr heating cycles) cyclic tests. It is felt that this is due primarily to the differences in power (11 vs. 20 kW) used in plasma spraying the bond coating. Spraying at 20 kW produced a much better bond coating.

Figure 7. - Effect of cycling frequency on life of TBC ZrO_2 - $12Y_2O_3$ on Ni-15. 8 Cr-12. 8AI-0. 36Y on solid Rene´41 pins in a Mach 0. 3 burner rig at 1050° C.

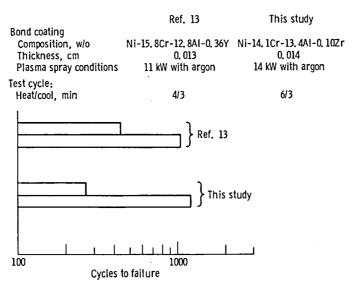
At least a three-fold improvement in life (short or long cycles) was obtained with the best bond coating. This is substantiated by the data presented in figure 8. Since the TBC performance with the Ni-15.8Cr-12.8Al-0.36Y and Ni-14.1Cr-13.4Al-0.10Zr bond coatings are about the same in the present study (fig. 2), the data of figure 8 show that no significant differences were obtained in the two studies for specimens coated using about the same plasma spraying conditions.

Figure 8. - Comparison of $\rm ZrO_2$ -12 $\rm Y_2O_3$ TBC lives obtained in reference 13 and in this study.

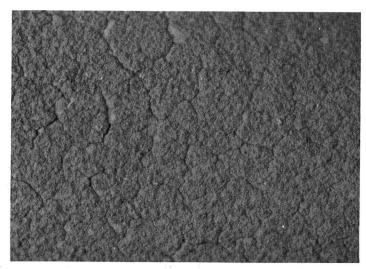
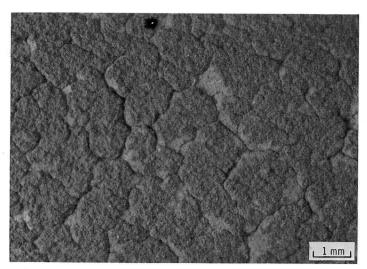
The TBC failures observed visually on the specimens tested using the 1.0- and 0.1-hour heating cycles were similar (typical examples, see figs. 3(a) and 3(b)). However, all the specimens tested using the 1.0-hour heating cycles also visually showed a "mud-flat" network after testing, but only on the front surfaces. Figure 9 shows examples of the mud-flat network. is evident in this figure, the network became more prominent as testing continued. It is felt that the network is a result of microcracking due to a combination of thermal shock cycling, sintering, and subsequent microspalling of the TBC. This is supported by observations noted when several of the tested specimens were examined in a scanning electron microscope (SEM). The topographical features of the TBC after test on two specimens are presented in the SEM photomicrographs of figure 10. Figure 10(a) shows the prominent mud-flat network on the front surface, but only apparent microcracking on the back surface. Figures 9(a) and 10(a) are photographs of the same speci-Figure 10(b) shows only microcracking of the TBC on both surfaces of a specimen tested in the burner rig using the shorter, 0.1-hour heating cycles. A distinctive mud-flat network has not developed at either location. Note that the degree of microcracking is significantly greater on the back surface of this specimen than on the front. The microcracking of the figure 10(b) specimen is much less extensive than that of the figure 10(a) specimen, because the former was at the maximum exposure temperature for only about 148 hours compared to about 380 hours for the latter.

Figure 9. – Photographs of front surfaces of ZrO $_2$ -12Y $_2$ O $_3$ Ni-14.1Cr-13. 4AI-0.10Zr coated René 41 pins after cyclic oxidation exposure in a Mach 0.3 burner rig at 1050 0 C. Heating cycles: 1 hour.

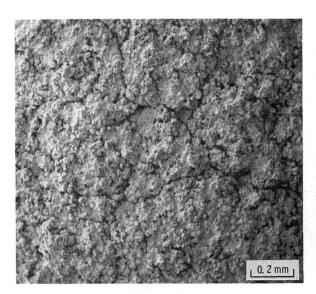
(a-2) Back surface.

(a) 400, 1-hour cycles (380 hr at maximum exposure temperature); ZrO_2 -12Y $_2O_3$ Ni-14, 1Cr-13, 4AI-0, 1Zr coating.

Figure 10. – Scanning electron photomicrographs of TBC systems on René 41 pins after cyclic oxidation exposure in a Mach 0. 3 burner rig at $1050^0\,$ C.

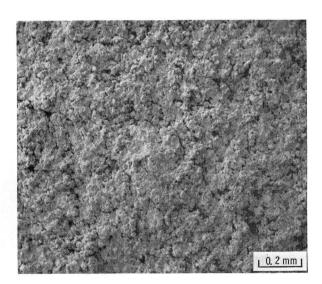
(b-2) Back surface.

(b) 2959, 0.1-hour cycles (~148 hr at maximum exposure temperature); ZrO_2 -12 Y_2O_3 Ni-14.1Cr-14.4AI-0.16Y coating.

Figure 10. - Concluded.

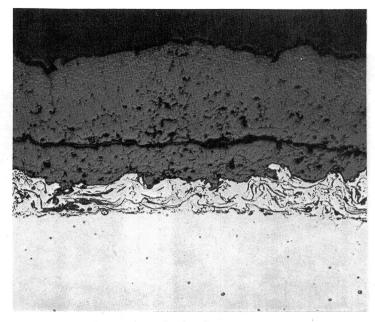
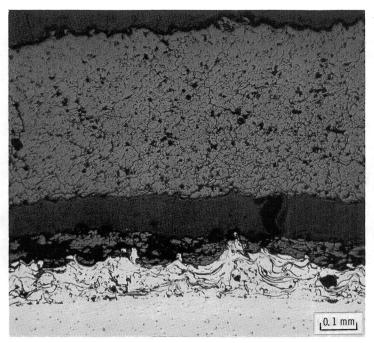
Figure 11 shows cross-sectional microstructures of a ZrO2-12Y2O3/Ni-14.1Cr-13.4Al-0.10Zr coated René 41 specimen after 400, 1-hour heating cycles in the 1050° C, Mach 0.3 rig test. Since this specimen after test showed only TBC cracking on the back surface (table II), the ceramic coating is intact on both surfaces. However, both microstructures in figure 11 show a large crack within the ceramic near and along the ceramic/bond coating interface, and numerous fine cracks throughout the ceramic. Note, that the extent of cracking (coarse and fine) is more extensive on the back surface than on the front. As stated above, fine cracks were observed on the external surfaces when examined directly (before sectioning) in the SEM. These observations suggest that the TBC fails by the following mechanism: (1) extension and linking of existing fine cracks throughout the ceramic coating, (2) coarse cracking within the ceramic along the ceramic/bond coating interface, (3) coarse cracking through the ceramic to its outer surface, and

Figure 11. - Photomicrographs of ZrO₂-12Y₂O₃Ni-14.1Cr-13.4AI-0.1Zr coated René 41 pins after 400, 1-hour heating cycles in a Mach 0.3 burner rig at 1050⁰ C. Bond coating: 0, 015 cm thick applied at 20 kW using argon-3.5 v/o hydrogen. TBC: 0, 038 cm thick.
